Manhole Inspection Summary

Manhole # S33G__032MH

Insp Date: **8/14/08 11:08 AM**

Location Address: **101 w baltimore**

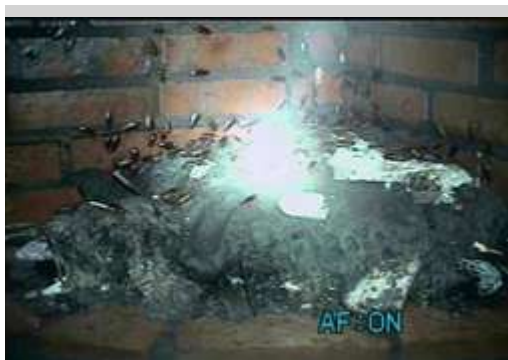
Defect 5

Condition: ☐ Sound ☐ Cracked ☐ Root Intrusion ☐ Deteriorated ☐ Leaks ☒ **Debris**

bench debris

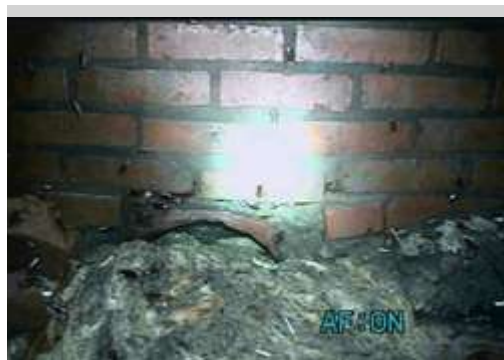
Defect 4

Condition: ☐ Sound ☐ Cracked ☐ Root Intrusion ☐ Deteriorated ☐ Leaks ☒ **Debris**

channel debris

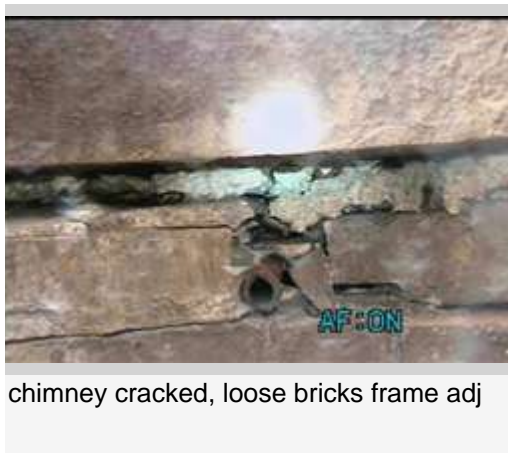
Defect 3

Condition: ☐ Sound ☒ **Cracked** ☐ Root Intrusion ☒ **Loose Brick** ☒ **Deteriorated**

chimney cracked, loose bricks frame adj

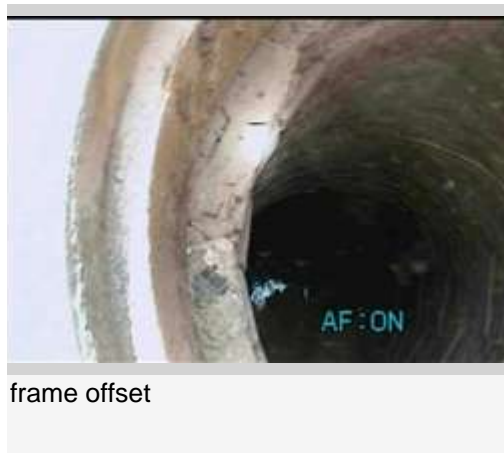
Defect 2

Offset: **2** (in.)

Condition: ☐ Sound ☒ **Cracked** ☐ Leaks

frame offset

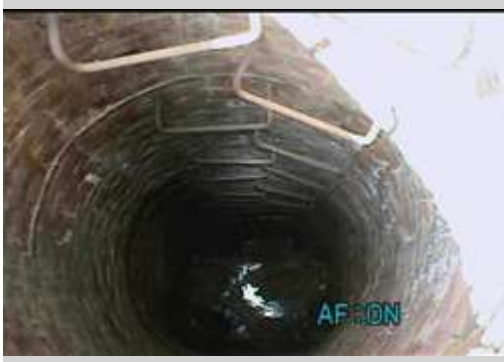
Defect 1

Count: **20** Missing: **0** ☒ **Corroded**

corroded steps

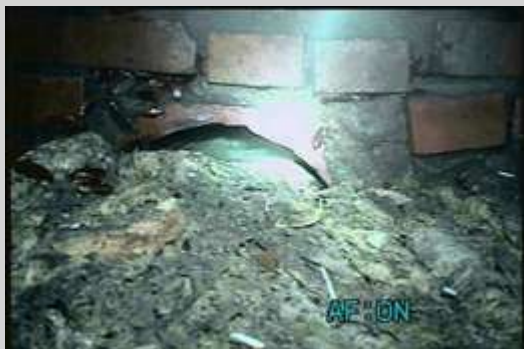
6 O'Clock Inflow

Deposits: ☐ None ☐ Mud ☐ Sludge ☒ **Debris** ☐ Grease

Silt Depth: 8 (in.) Deposits Extent: **Heavy**
